Howe-Manning School

Middleton, MA

RF Walsh Collaborative Partners

REPORT NO. 19 Week Ending Aug 28, 2010

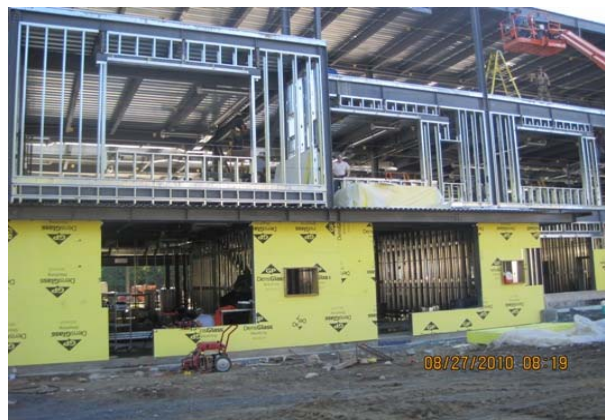
Exterior framing and sheathing
